FIELD INSPECTION

Project Name:	Mountain Valley Pipeline	Inspector:	Matthew Grant
Inspection Date:	Thursday, January 10, 2019	Project Contact:	Brian Clauto
Spread: Montgomery County MP228-231	Spread H	Weather (Wet/Dry/Rain):	Dry

FIELD INSPECTION PHOTO LOG

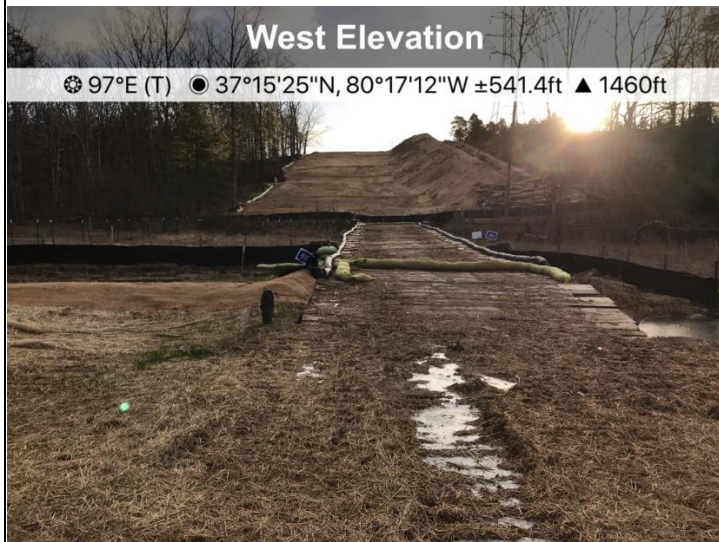
- MP 229 St#12132+91 CFS is torn and bridge crossing near designated stream SC-29
- MP 231 St#12235+92 area has been stabilized.
- MP 228 St#12072+84 area has been stabilized.
- MP 230 St#12152+00 area has been stabilized
- ECD are in place and functioning at designated streams SMM-11, SMM-13, SF-16

- Fig. 1 CFS at st#12132+91 is torn at bridge crossing

Recommended Corrective Action: Maintain all controls per the approved plan and annual standards and specs.

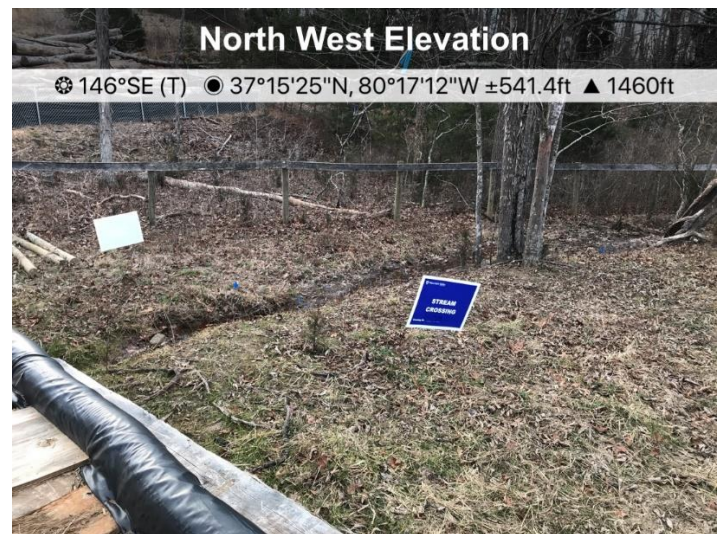
- Fig. 2 Designated stream SC-29 controls in place and functioning

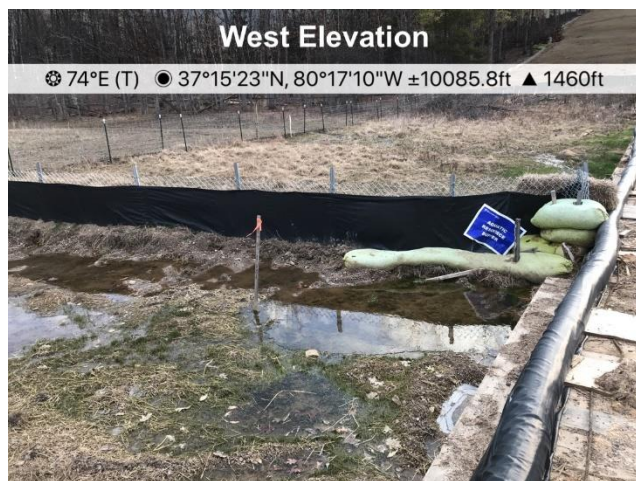
- Fig. 3 Aquatic resource at ST#12132+00 repairs have been made and controls in place and functioning.

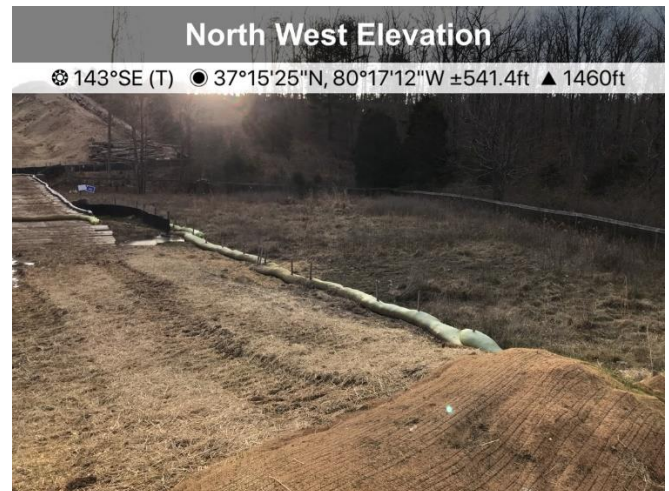
- Fig. 4 Aquatic resource at ST#12132+00 repairs have been made and controls in place and functioning.

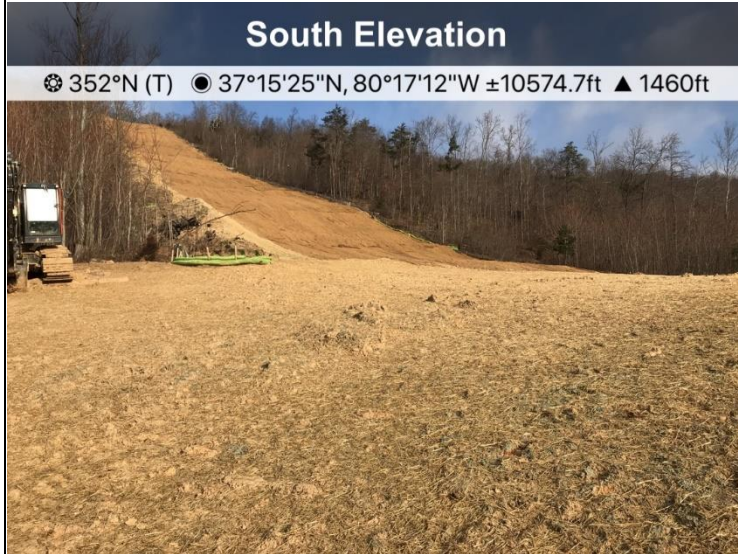
- Fig. 5 MP 228 St#12072+84 area has been stabilized

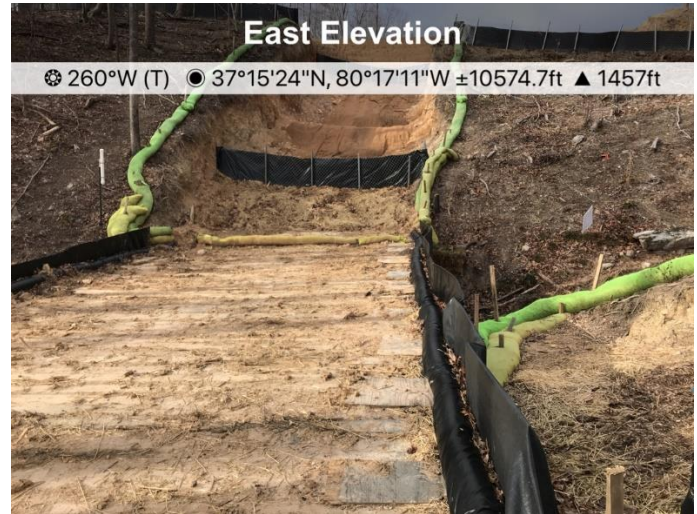
- Fig. 6 ECD are in place and functioning at designated stream SMM-13

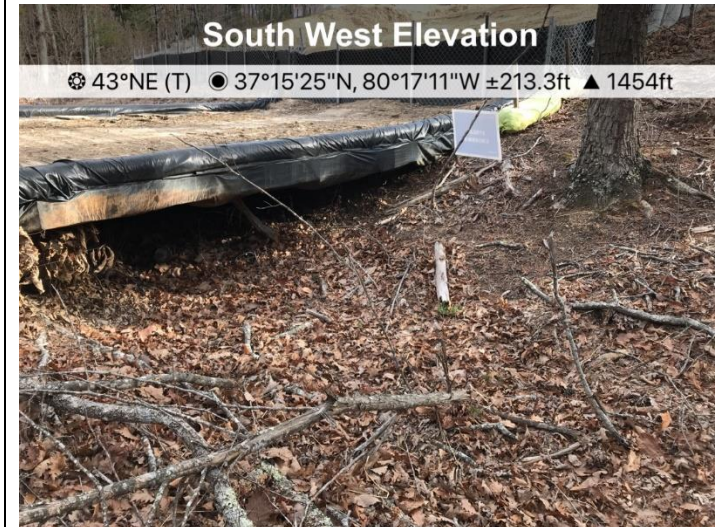
- Fig. 7 ECD are in place and functioning at designated stream SF-16

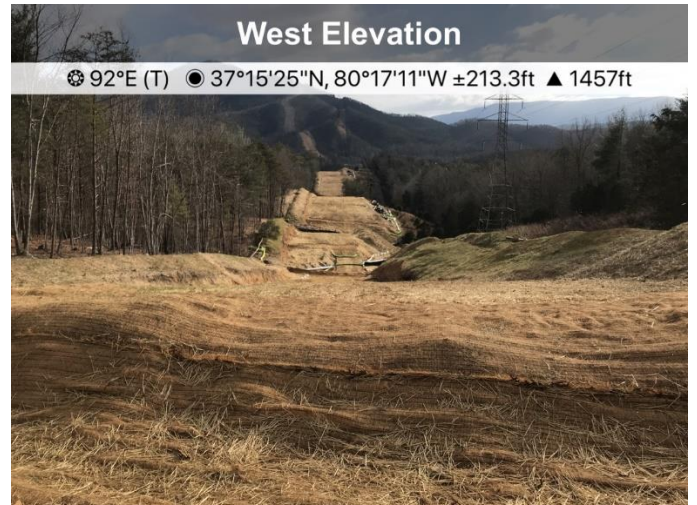
- Fig. 8 MP230 St#12152+00 area has been stabilized
